**Flood Control Project Maintenance  
Levee Inspections**

**Fall 2010 Levee Maintenance Deficiency Summary Report**

**Sacramento River Basin**

**Tehama County Flood Control and Water Conservation District**

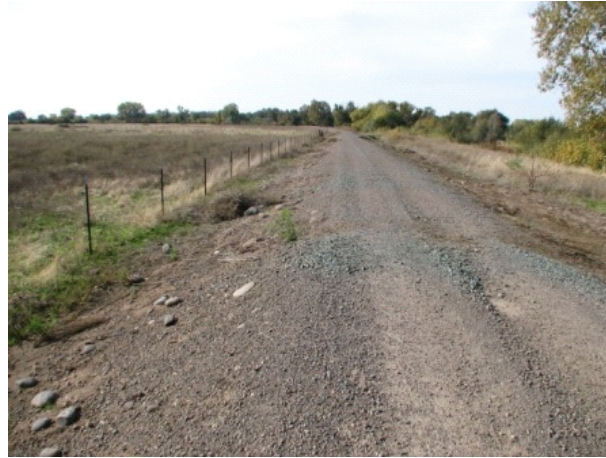
Levee Mile Report Line	2
Start Levee Mile	2.72
End Levee Mile	2.76
Location	Crown
Category	Earthen Levee
Item	Slope Stability

Erosion on crown and both slopes.

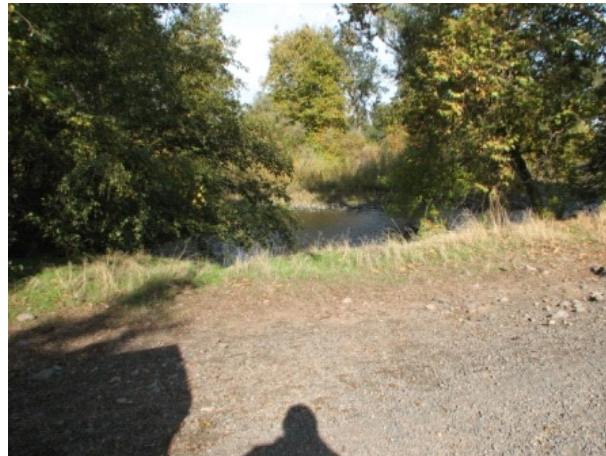
Levee Mile Report Line	3
Start Levee Mile	2.79
End Levee Mile	2.79
Location	Water Side
Category	Earthen Levee
Item	Erosion / Bank Caving

Erosion along the channel.

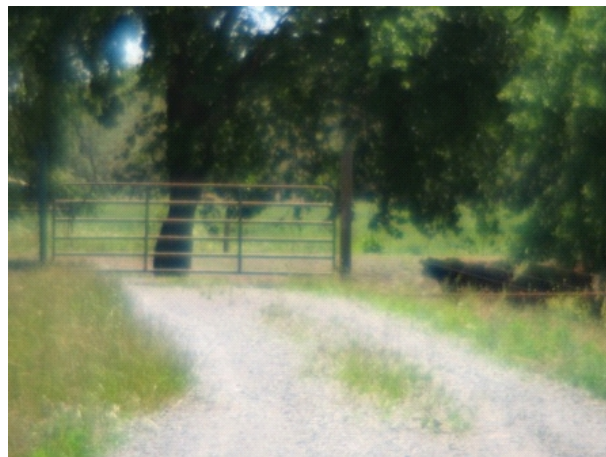
Levee Mile Report Line	7
Start Levee Mile	3.64
End Levee Mile	3.64
Location	Crown
Category	Earthen Levee
Item	Encroachments

View of the non-permitted gate on the crown of the levee.

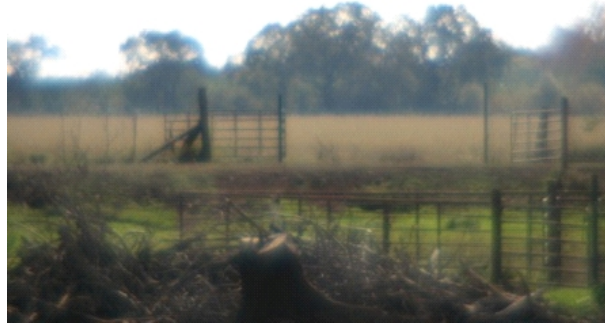
Levee Mile Report Line	8
Start Levee Mile	3.74
End Levee Mile	3.74
Location	Crown
Category	Earthen Levee
Item	Encroachments
View of the nonpermitted gate on the crown roadway.	
rduffey_f_20101110_266.jpg

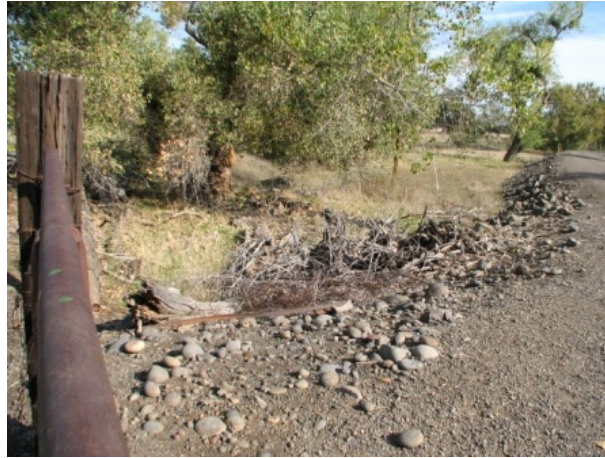
Levee Mile Report Line	1
Start Levee Mile	0.31
End Levee Mile	0.31
Location	Land Side
Category	Earthen Levee
Item	Encroachments

View of debris & wire at toe of levee.

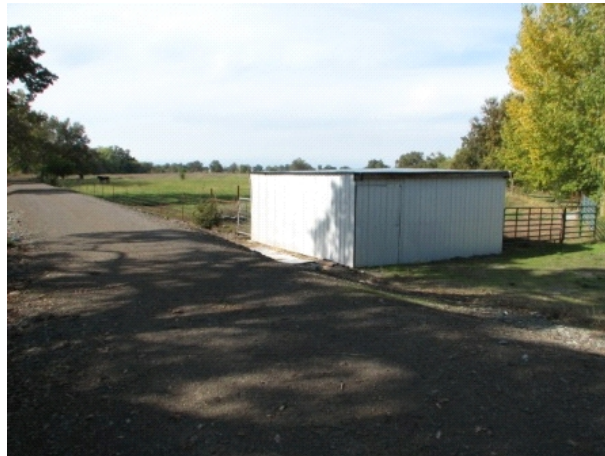
Levee Mile Report Line	2
Start Levee Mile	0.36
End Levee Mile	0.36
Location	Land Side
Category	Earthen Levee
Item	Encroachments

View of building at toe of levee.

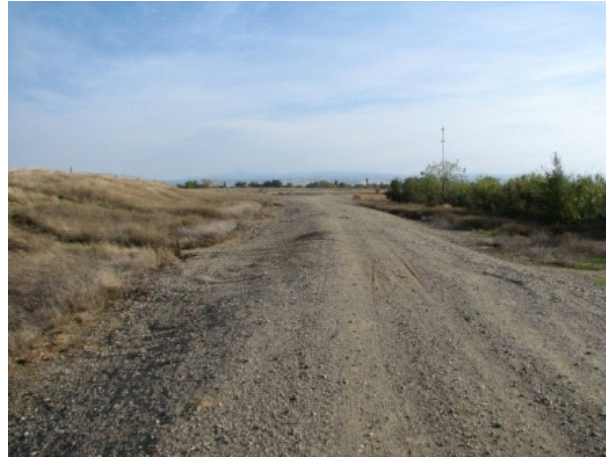
Levee Mile Report Line	1
Start Levee Mile	1.60
End Levee Mile	1.71
Location	Water Side
Category	Earthen Levee
Item	Slope Stability

View of vehicle erosion on the crown & both slopes.

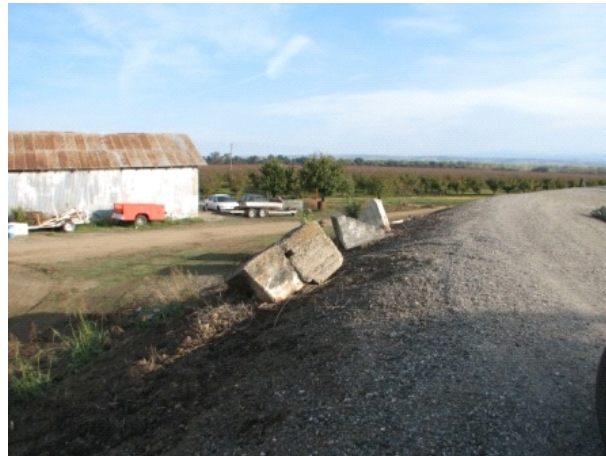
Levee Mile Report Line	7
Start Levee Mile	3.15
End Levee Mile	3.15
Location	Land Side
Category	Earthen Levee
Item	Encroachments

View of the concrete stairways on the slope.

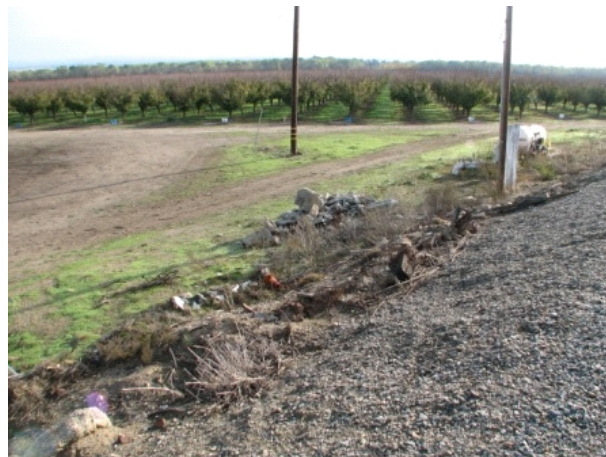
Levee Mile Report Line	8
Start Levee Mile	3.34
End Levee Mile	3.34
Location	Land Side
Category	Earthen Levee
Item	Encroachments

View of the garbage and metal at the toe of the levee & along the slope of the landside.

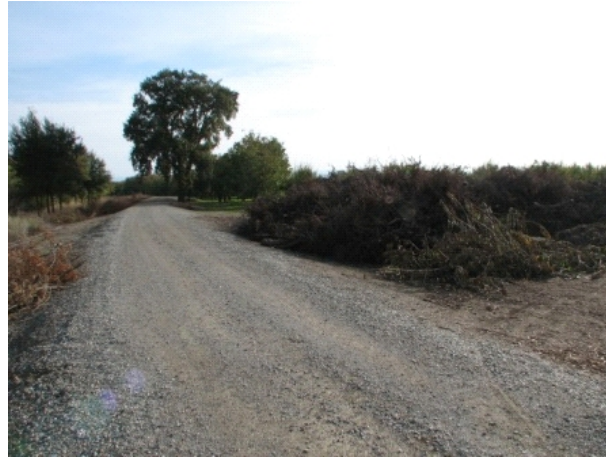
Levee Mile Report Line	1
Start Levee Mile	0.81
End Levee Mile	0.81
Location	Land Side
Category	Earthen Levee
Item	Encroachments

View of the debris & pruning pile brush next to the toe.

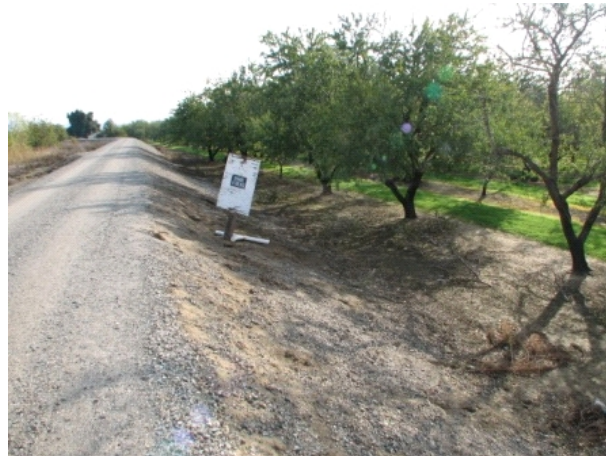
Levee Mile Report Line	2
Start Levee Mile	2.57
End Levee Mile	2.57
Location	Land Side
Category	Earthen Levee
Item	Animal Control

View of the bait station next to the squirrel holes on the landside slope.

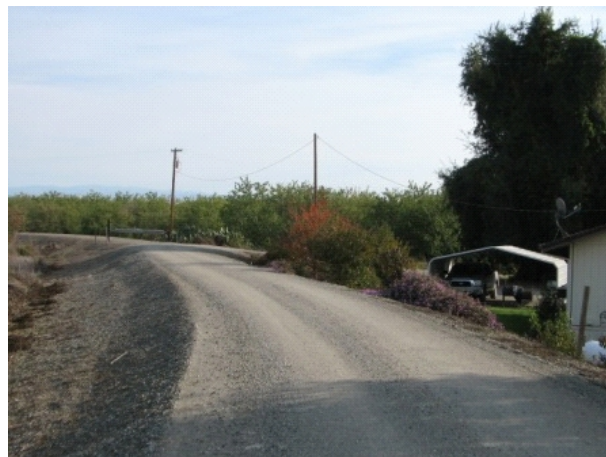
Levee Mile Report Line	3
Start Levee Mile	2.70
End Levee Mile	2.76
Location	Land Side
Category	Earthen Levee
Item	Encroachments

View of the landscape along the slope.
